SECTION 319 NONPOINT SOURCE POLLUTION CONTROL PROGRAM

WATERSHED PROJECT FINAL REPORT

Segment 3C Characterization Project
Arrastra Basin
WQC02000019

ATTACHMENT 3
Macroinvertebrate Survey of Arrastra Creek, 2002

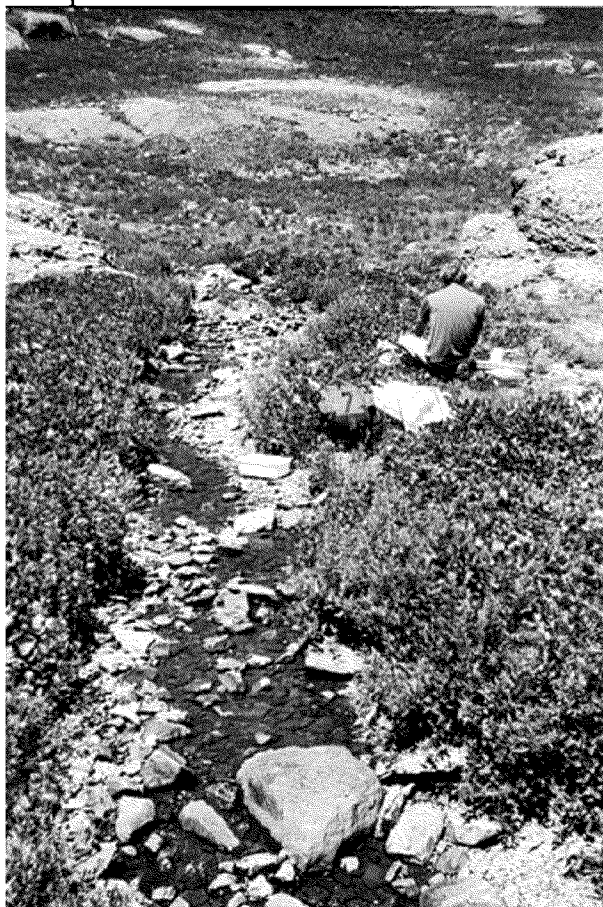
Figure 2. Silver Lake Inlet sample site.

At this site Arrastra Creek was approximately 0.5 meters wide with less than 5cm of water flowing over pebble to boulder size substrate. Substrate was covered with adnate algae (fig. 2).

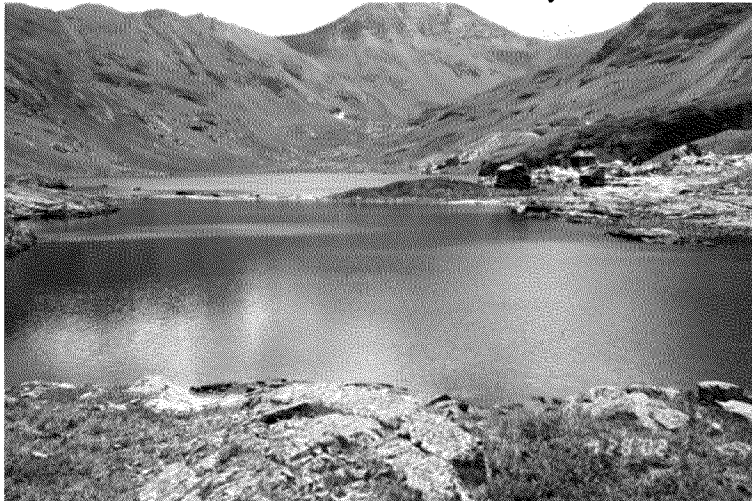
At this site the frame of the surber net was attached to a rope in 3 places and thrown into the lake and allowed to settle to the bottom. Then the net was pulled through the water to capture pelagic macro and meio invertebrates. No water chemistry data was obtained from this site (fig. 3).

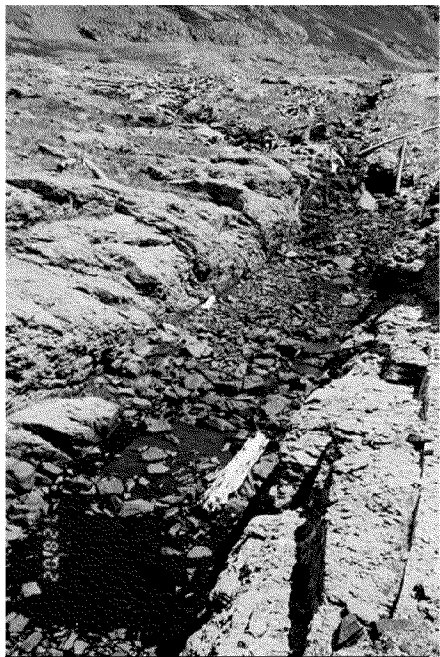
Figure 4. Below Silver Lake sample site.

Arrastra Creek at this sample site was similar in size to the Silver Lake Inlet sample site. Water flowed over boulder and bedrock substrate that was covered with adnate algae (fig. 4).

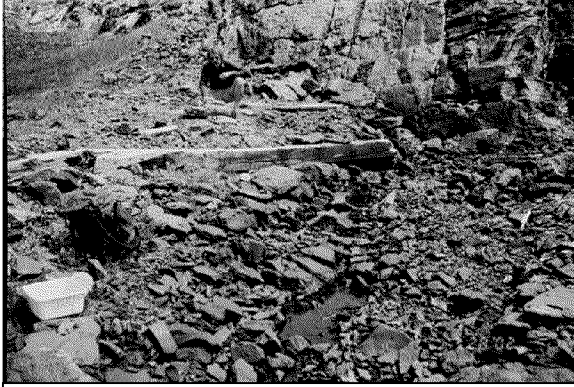
Figure 5. Above Drop to Mayflower sample site.

At this site the creek was small and warm with very little water running over boulders and bedrock. Wet substrate was covered with a small amount of adnate algae. Only macroinvertebrates were sampled at this site (fig. 5). Below this site there was no more surface water in the creek bed to at least the drop to the Mayflower mine.
